Limited Visual Dam Safety Inspection Summary Report

MA-081

Reservoir 61

Limited Visual Dam Safety Inspection Conducted on: 03 April 2006

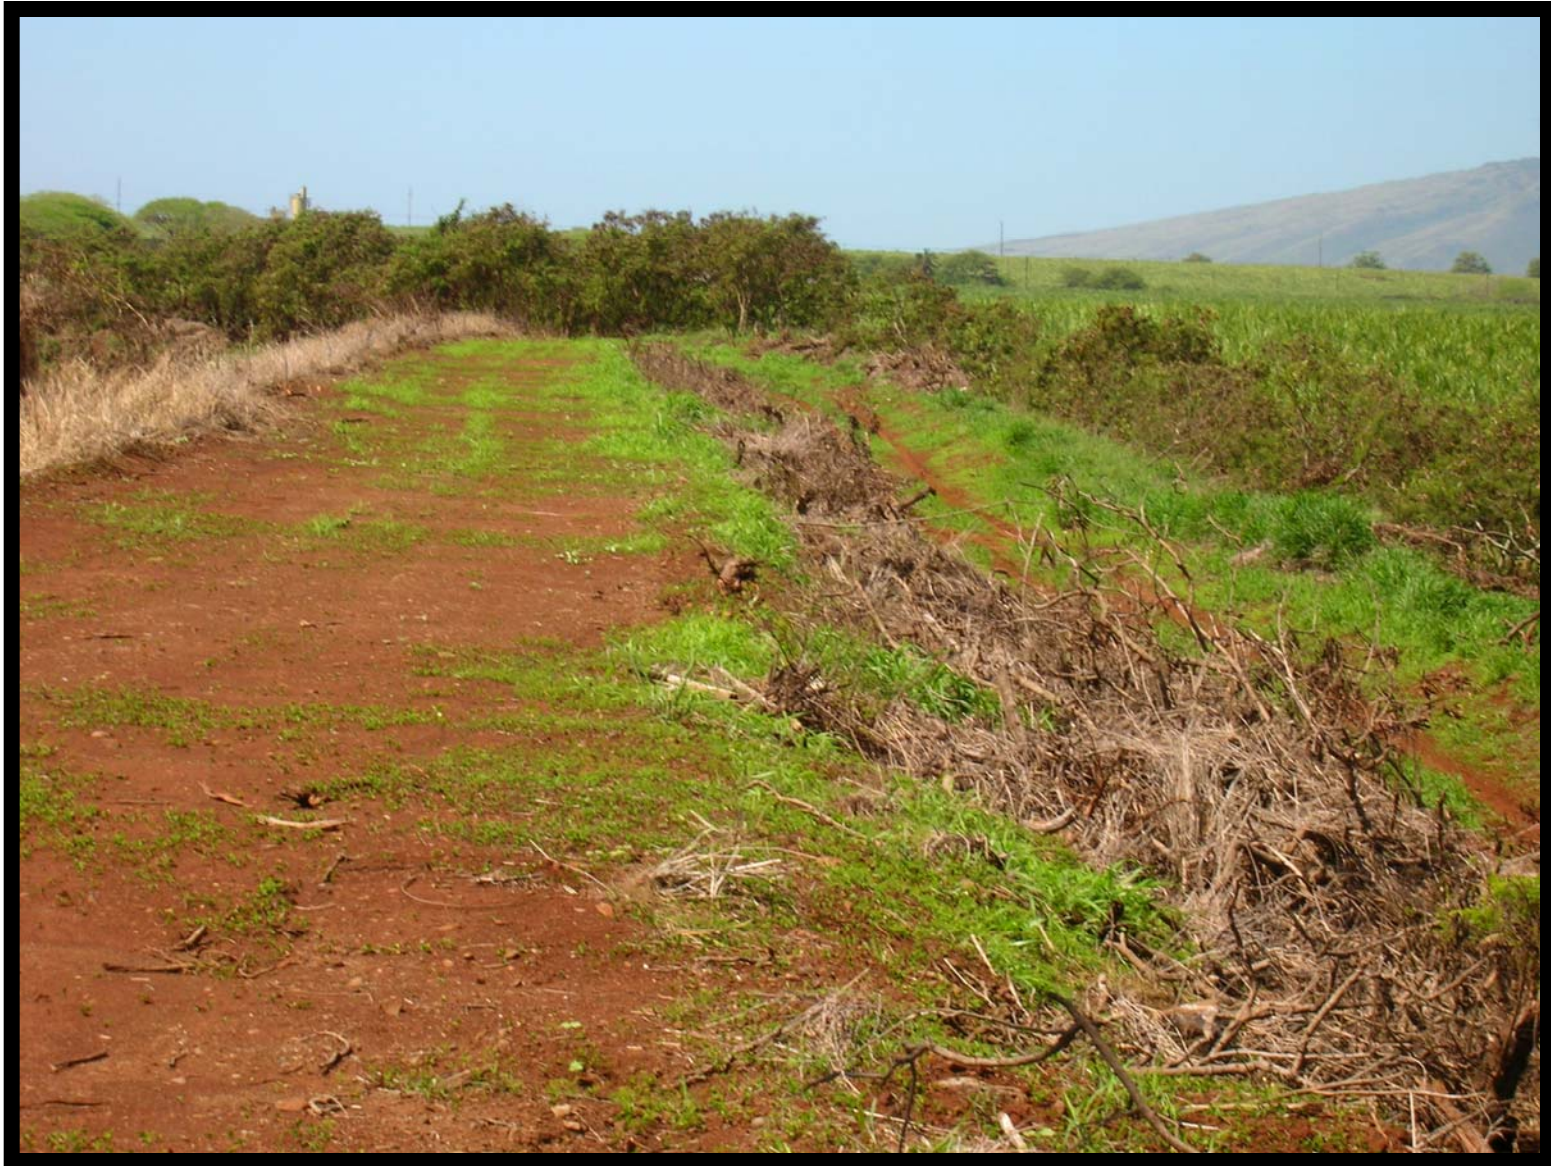
081 crest

- a. The dam crest appeared to be in satisfactory condition, no corrective actions are required at this time.

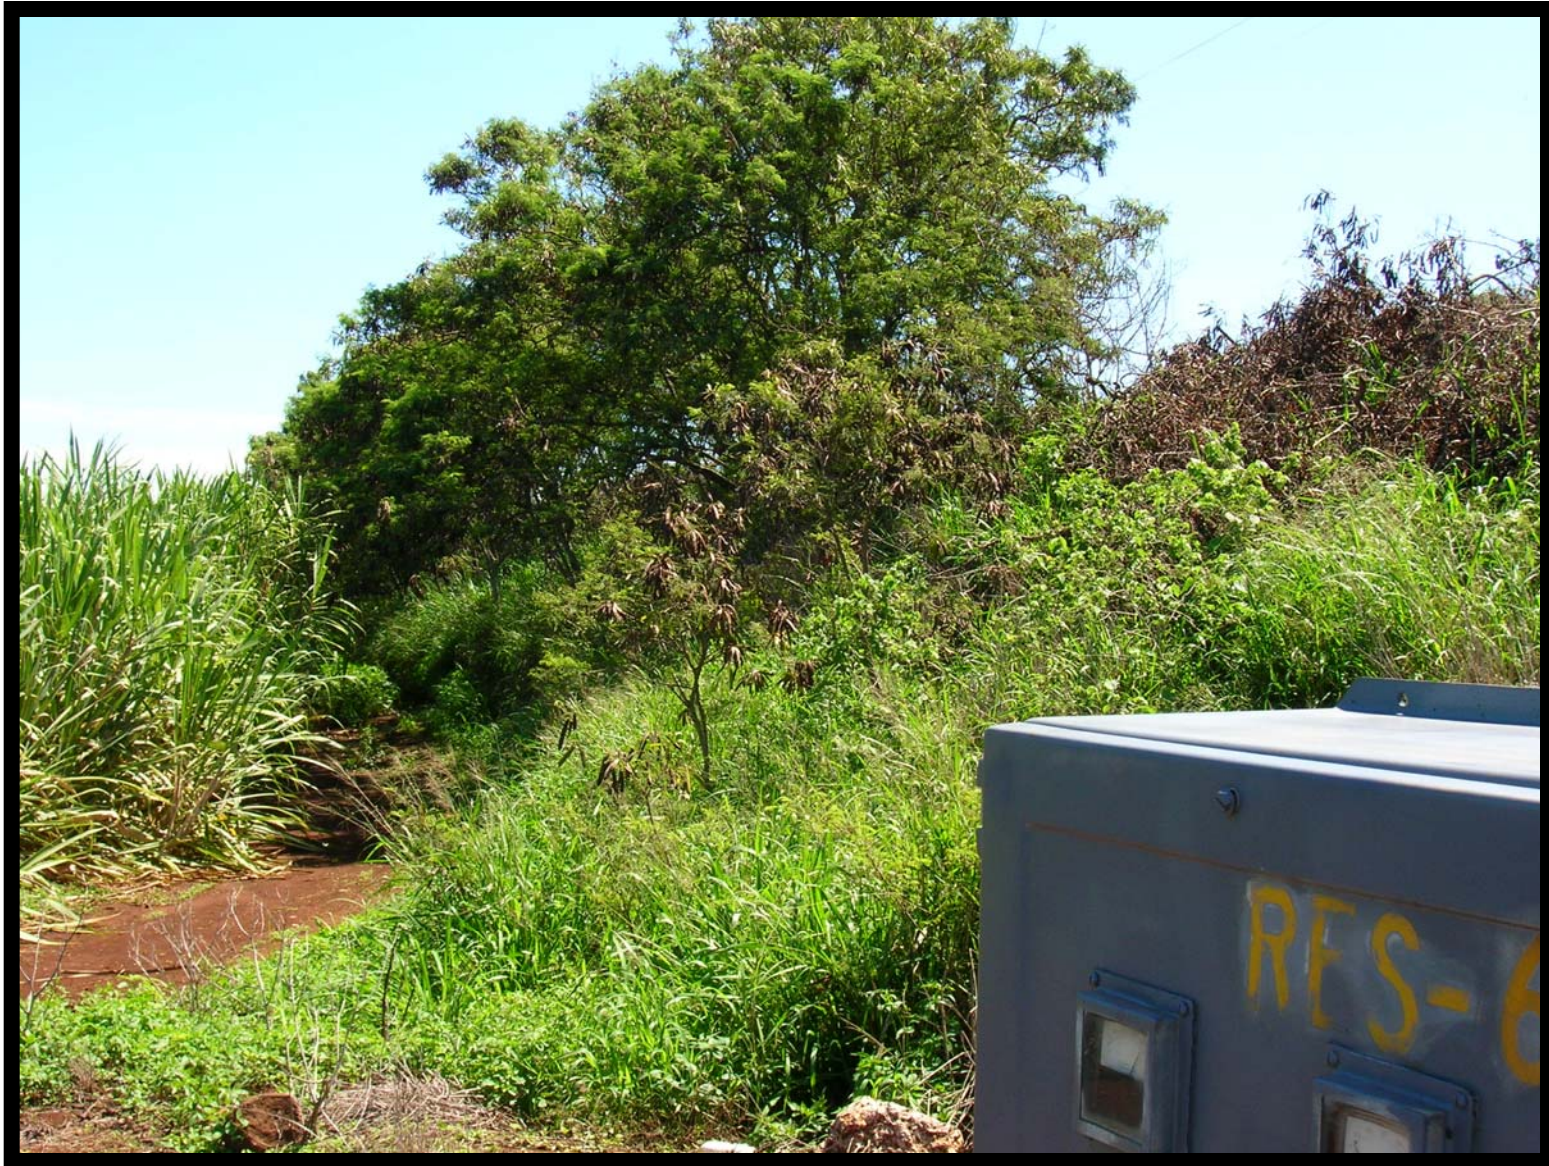
- a. The downstream slope appeared to be in fair to poor condition and requires corrective action.
- b. The down stream slope was not visible due to high grass and bush vegetation. Clear high vegetation and maintain low to enable easy visual inspection.

- c. Tree(s) were observed on the downstream slope. Trees have been identified as the probable cause of piping failures, and can possibly cause severe damage to the embankment if they are uprooted during high winds. Corrective action is required to remove the tree hazards from the dam. Acceptable remedies include removal of the tree and its root structure down to a 2" diameter and reconstruction the damaged embankment section. All repair work shall be accomplished as per the requirements of licensed geotechnical or structural engineer. Routinely monitor the damaged area for signs of settlement and seepage.

081 Downstream 1 - View of the downstream slope and toe. Note the trees, brush, and tall grass on the slope.

LONG TERM RECOMMENDATION: The upstream and downstream slopes of the embankment should be clear and visible for inspection. Underbrush should be cleared and grasses kept short. The dam owner routinely removes vegetation and trees from the slopes. The owner should continue with the routine removal of vegetation. At one location, recently cut trees and brush were left on the downstream slope. All cut vegetation debris should be removed off the embankments and disposed of offsite.

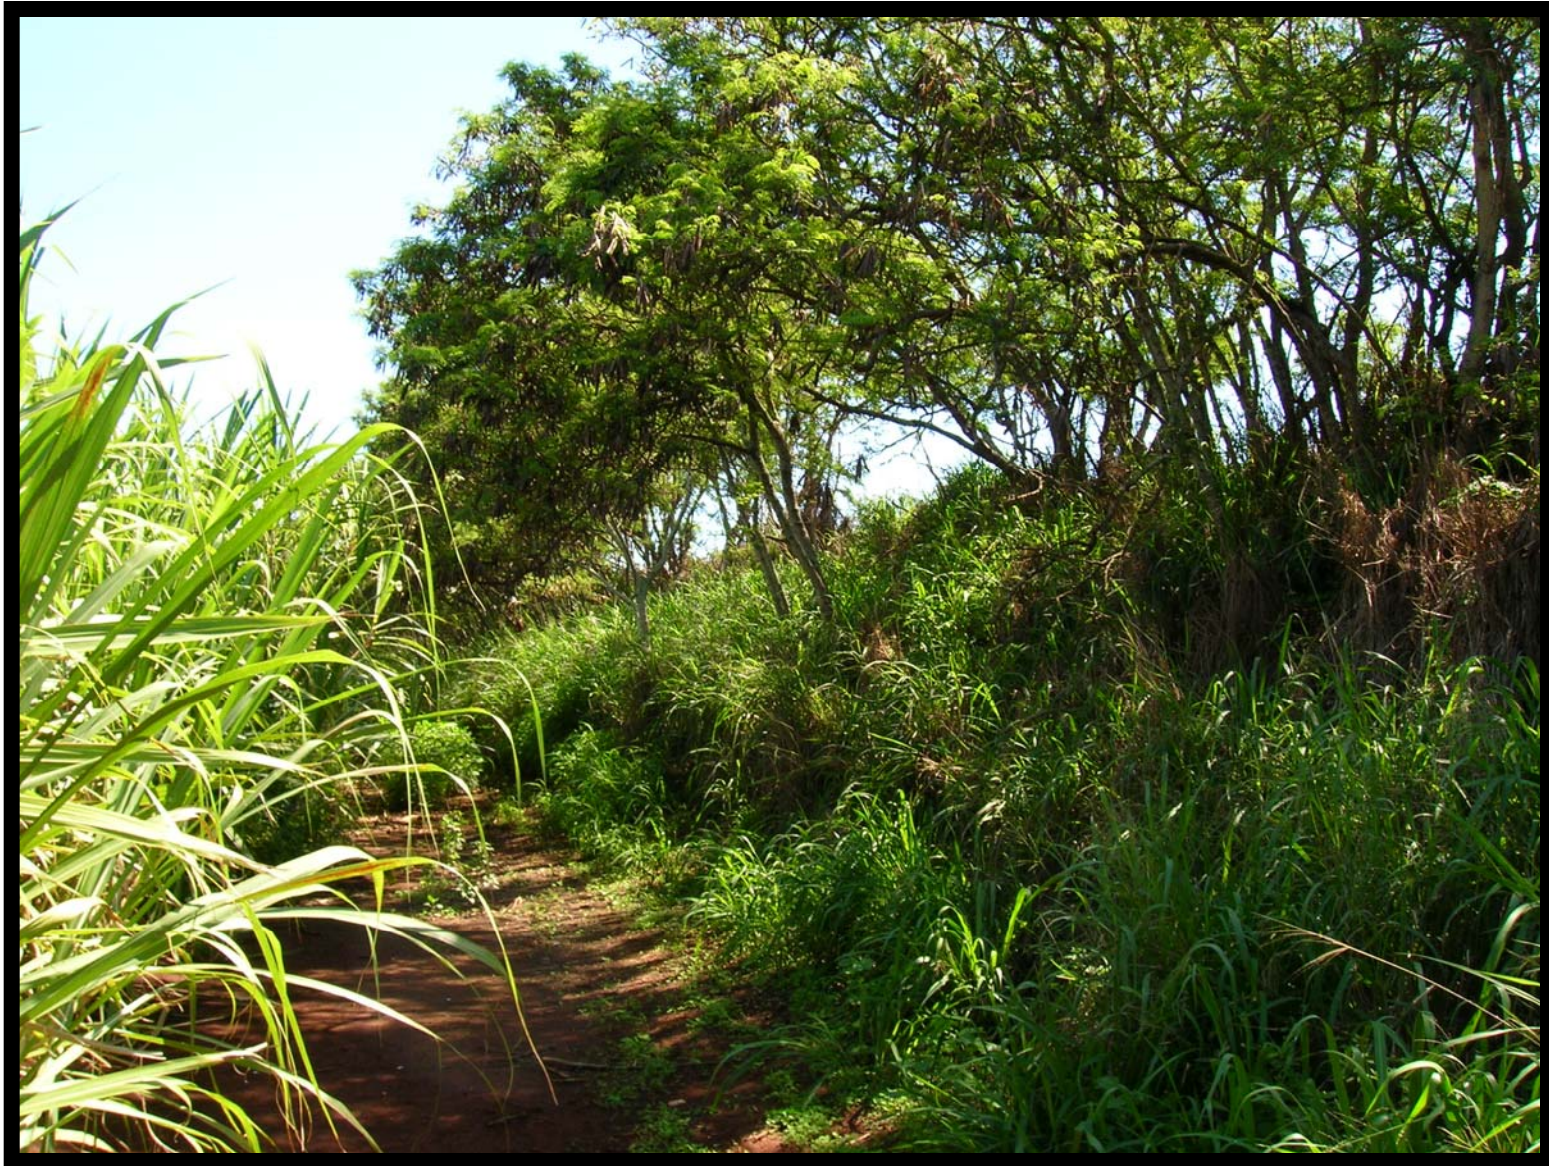
081 Downstream 2 - View of the downstream slope and toe. Note the trees, brush, and tall grass on the slope.

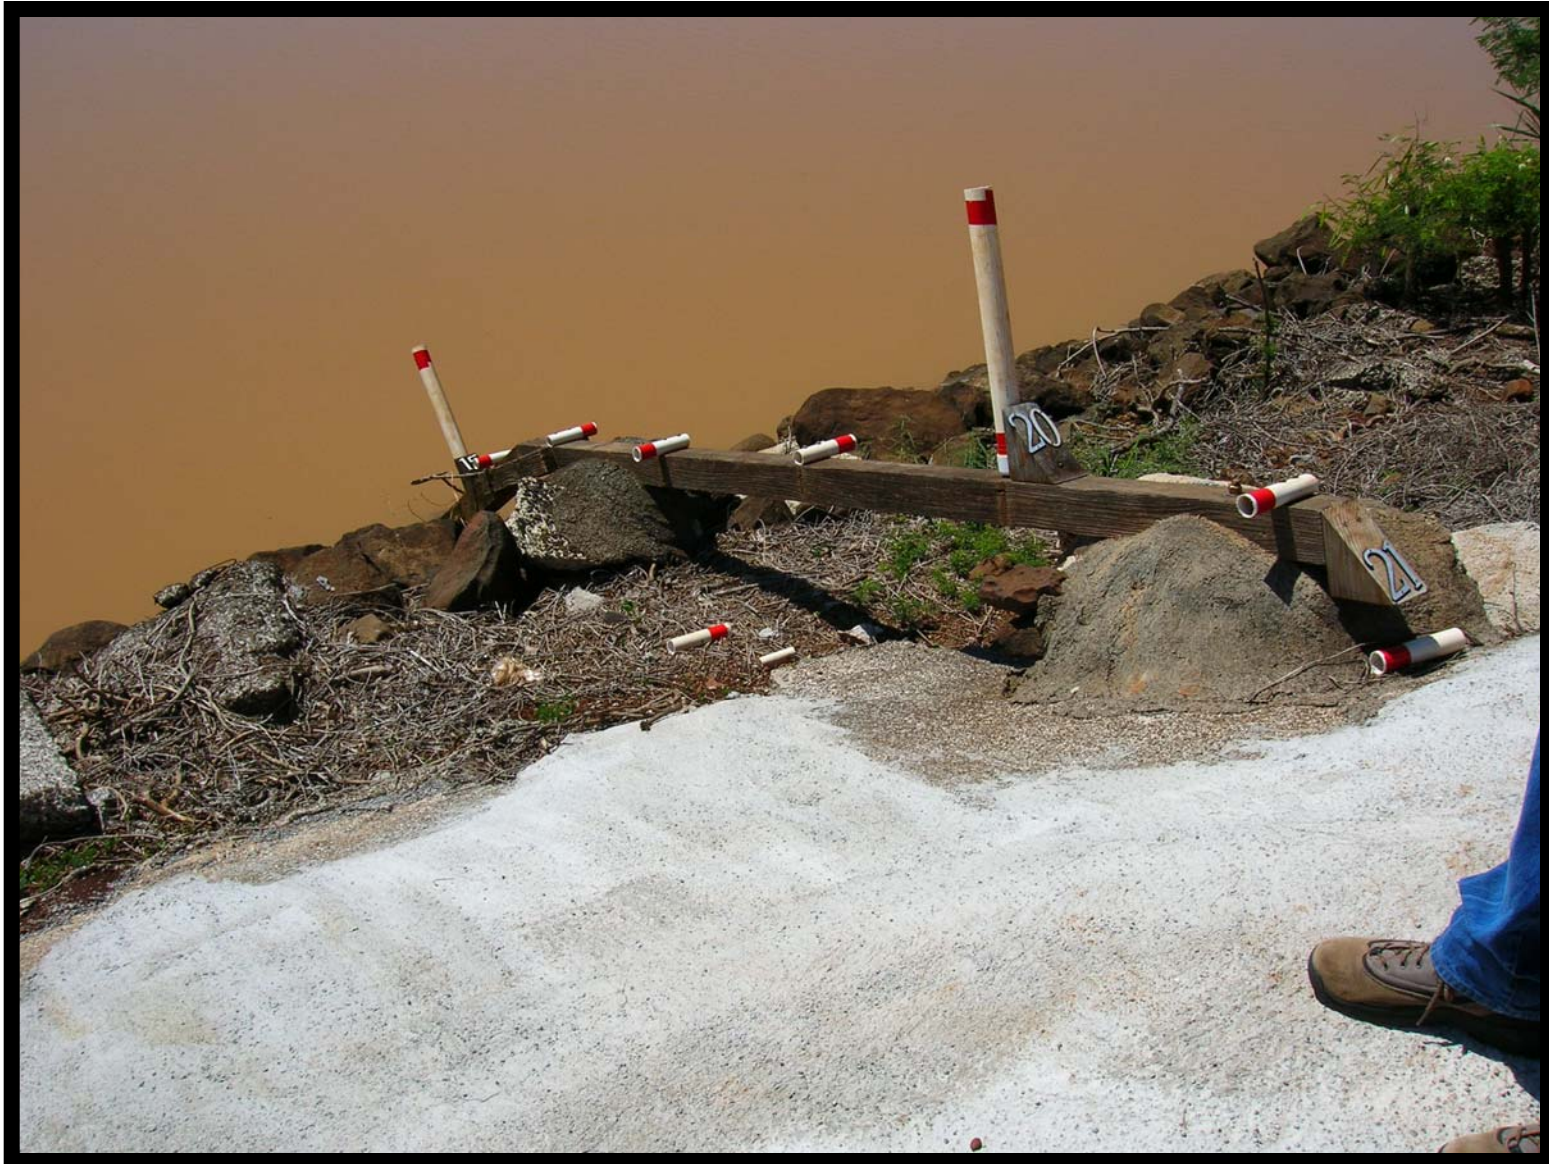
081 gage - View of the staff gage.

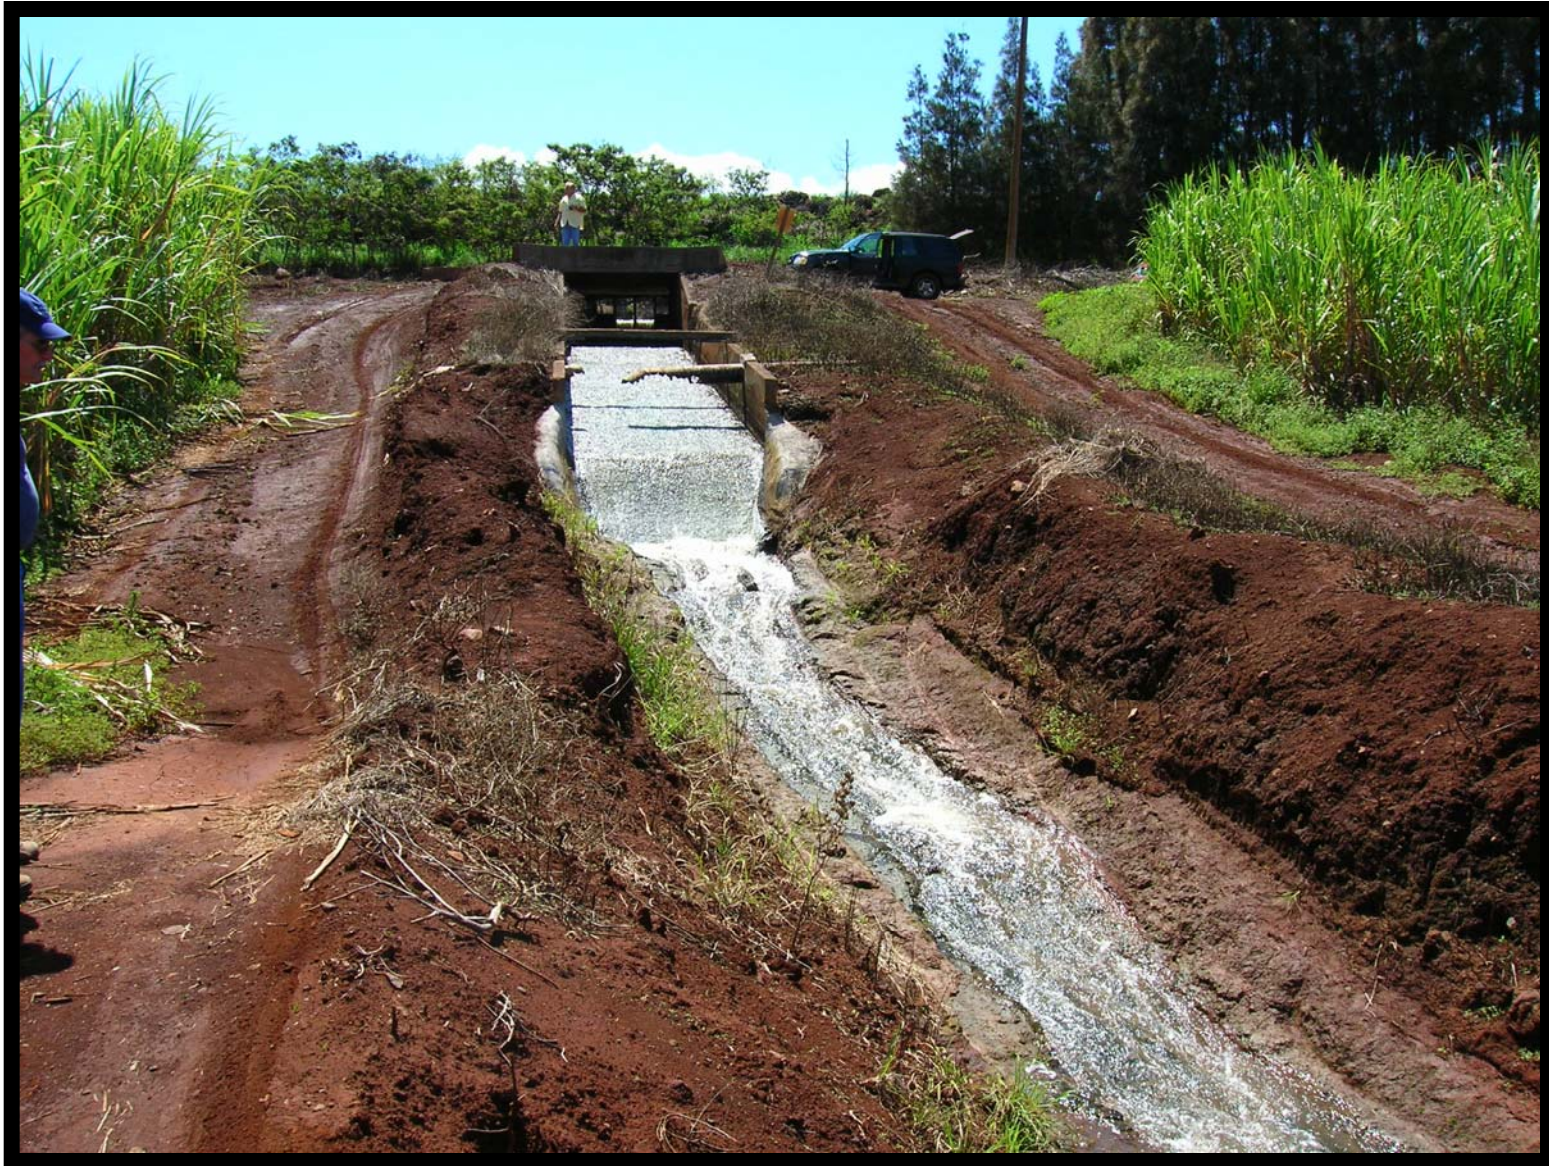
- a. The intake works were not tested.
- b. The intake works appeared to be in satisfactory condition, no corrective actions are required at this time.

081 intake1 - View of the intake ditch

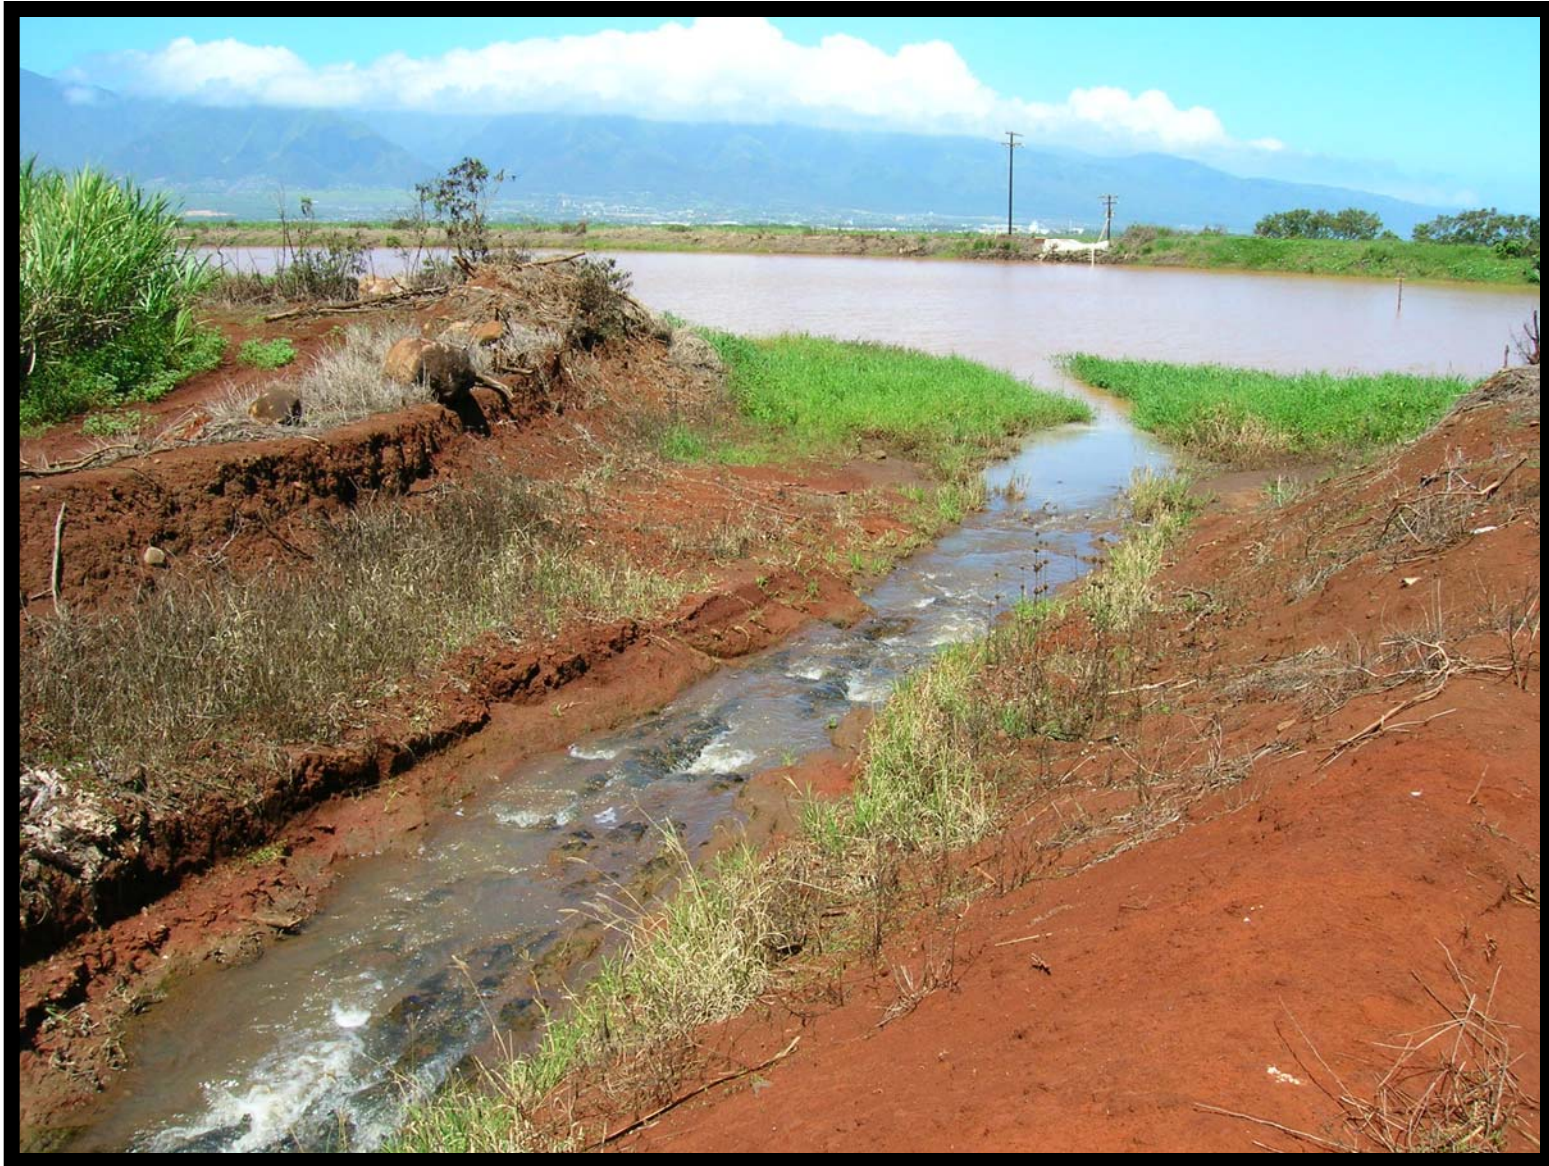
081 intake 2 - View of the intake ditch. Upstream slope of the dam is in the background.

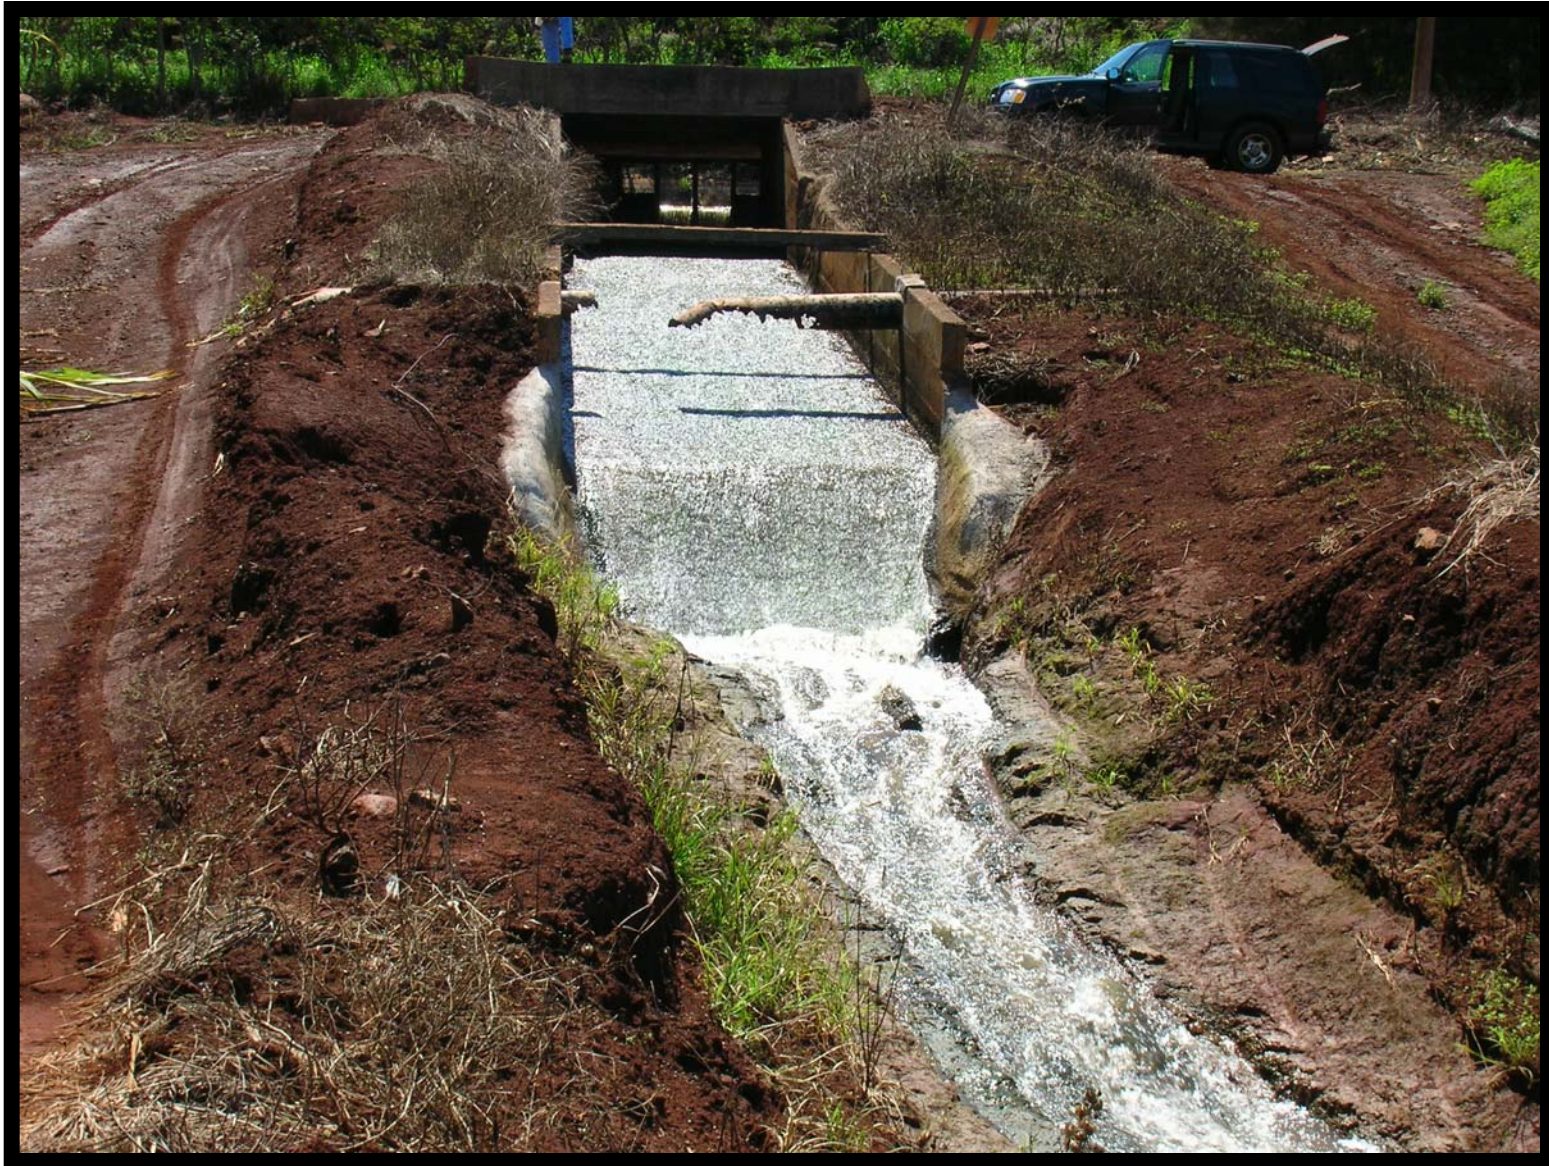
081 intake 3 - View of the intake ditch.

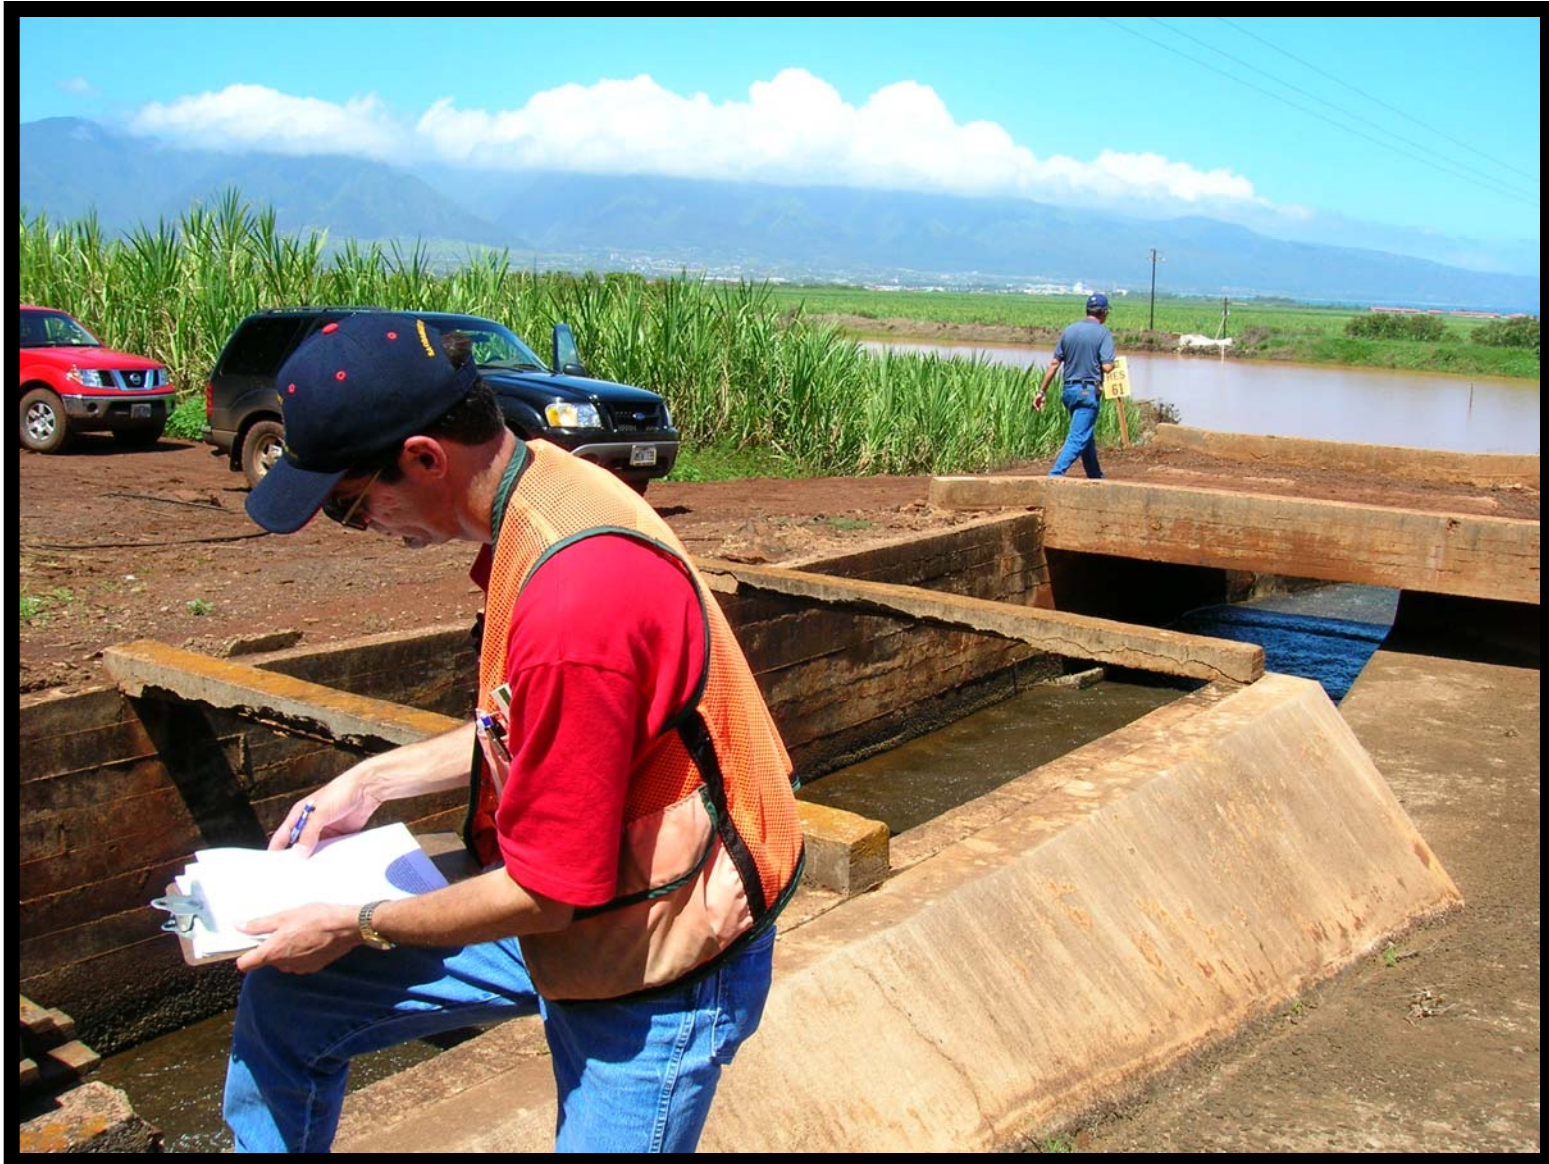
081 intake 4 - View of the intake ditch.

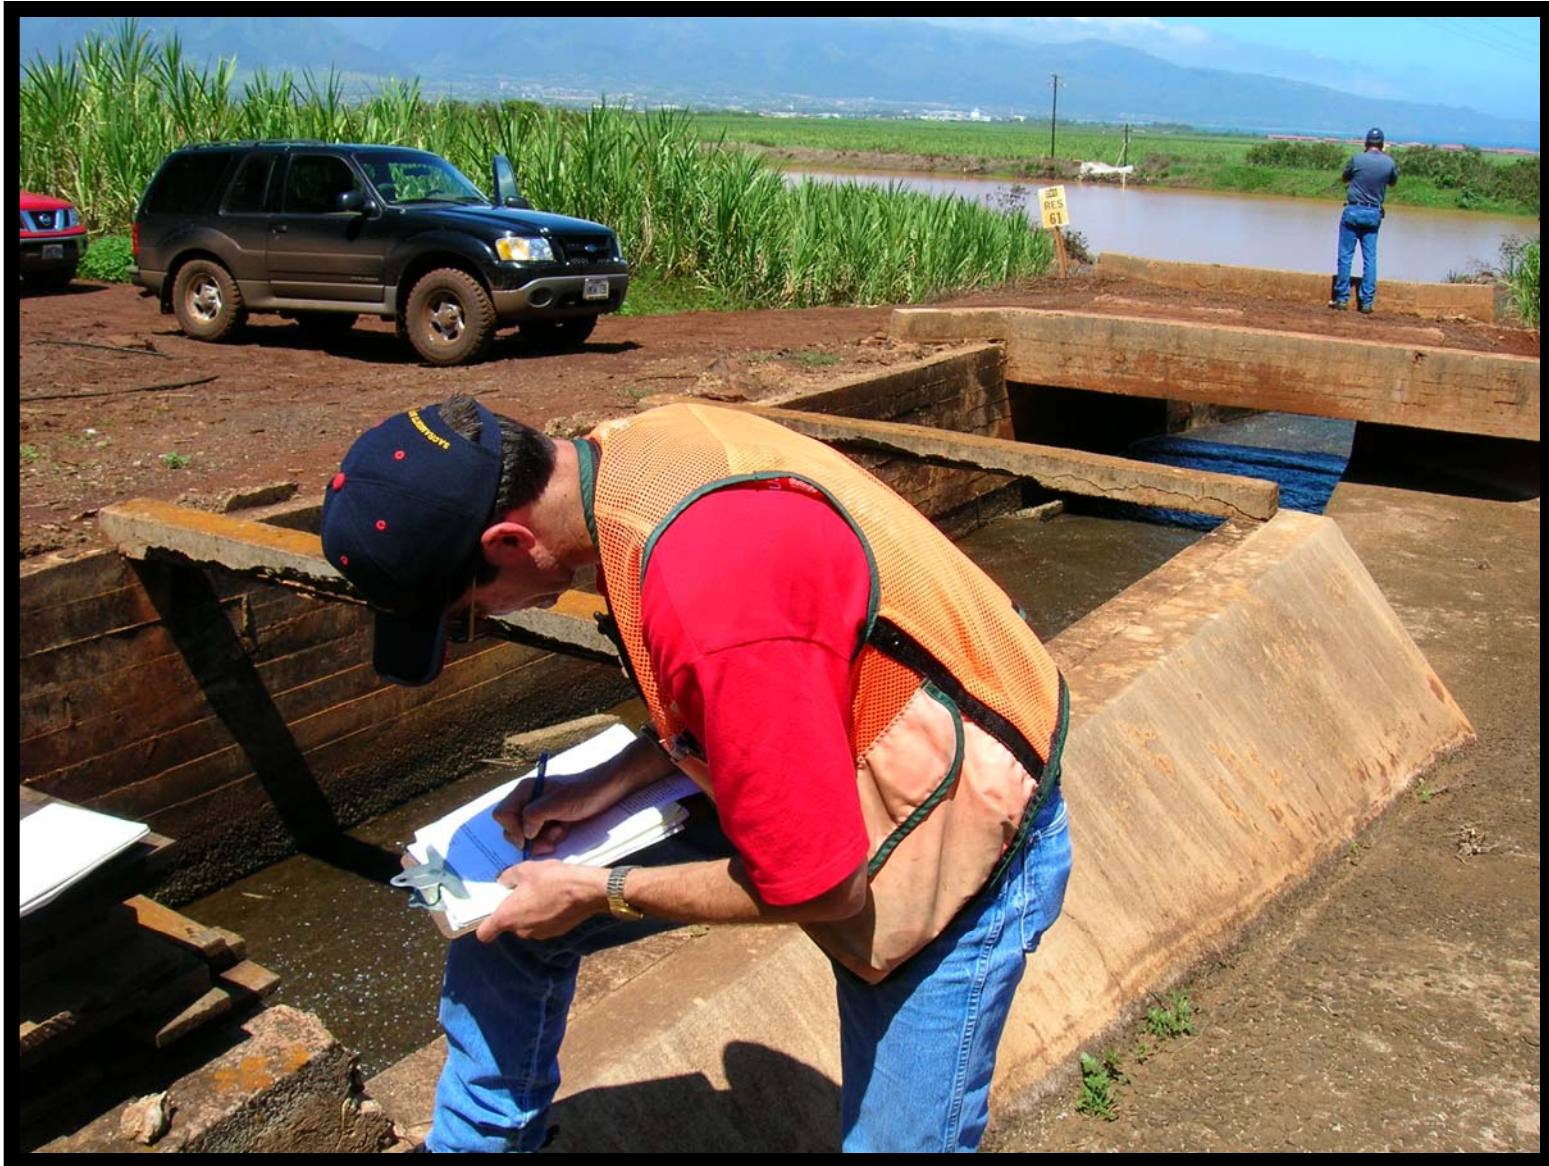
081 intake 5 - View of the intake ditch.

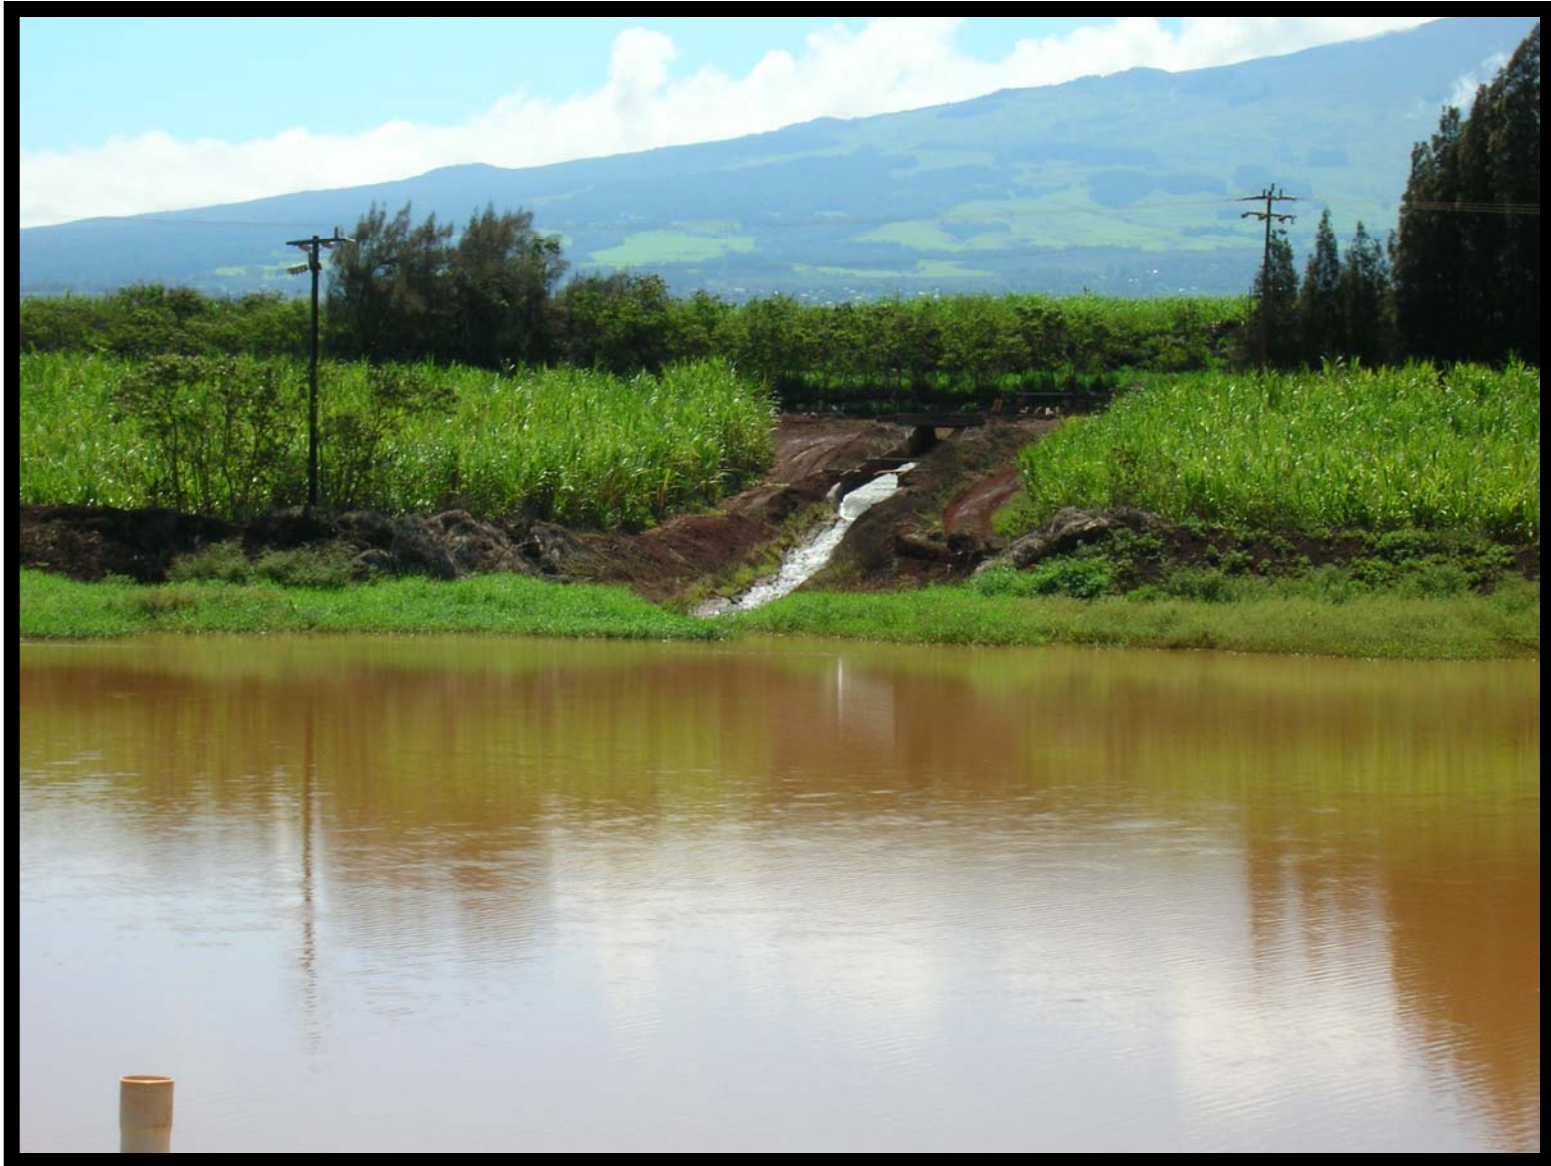
081 intake 6 - View of the intake ditch.

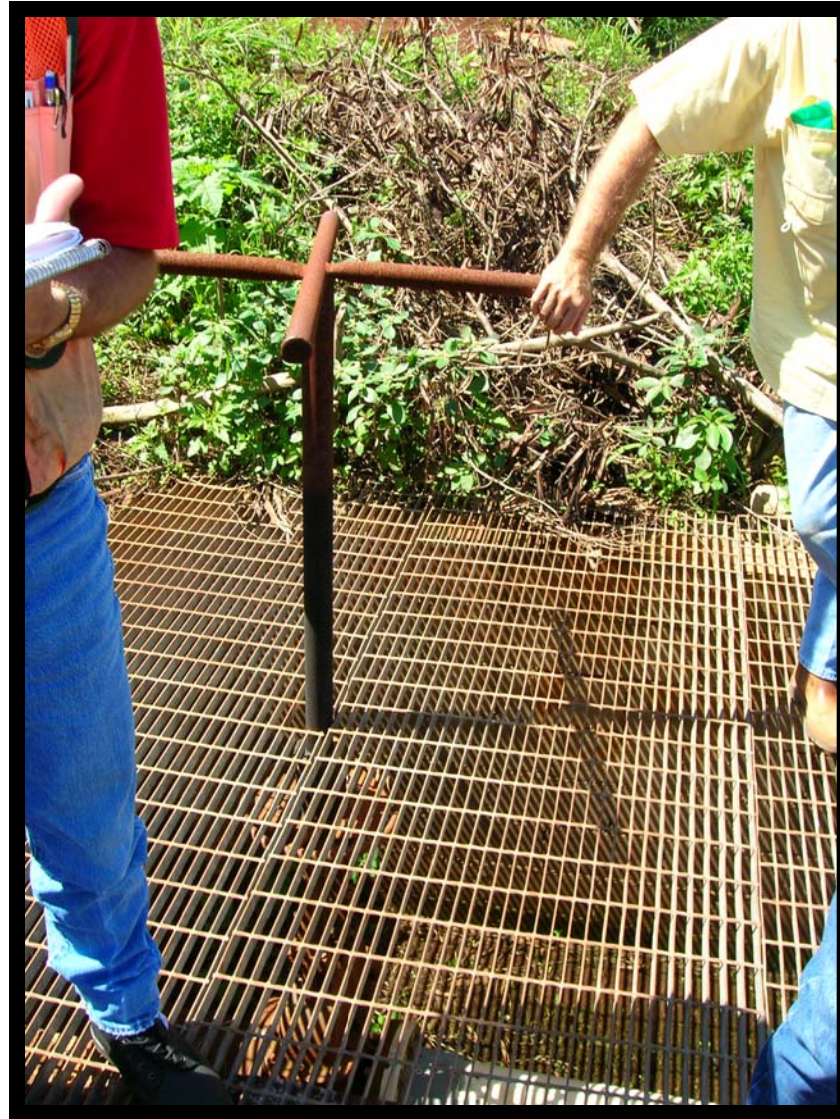
- a. The outlet works were not inspected.
- b. The outlet works appeared to be in satisfactory condition, no corrective actions are required at this time.

081 outlet - View of the outlet works (under the steel grating)

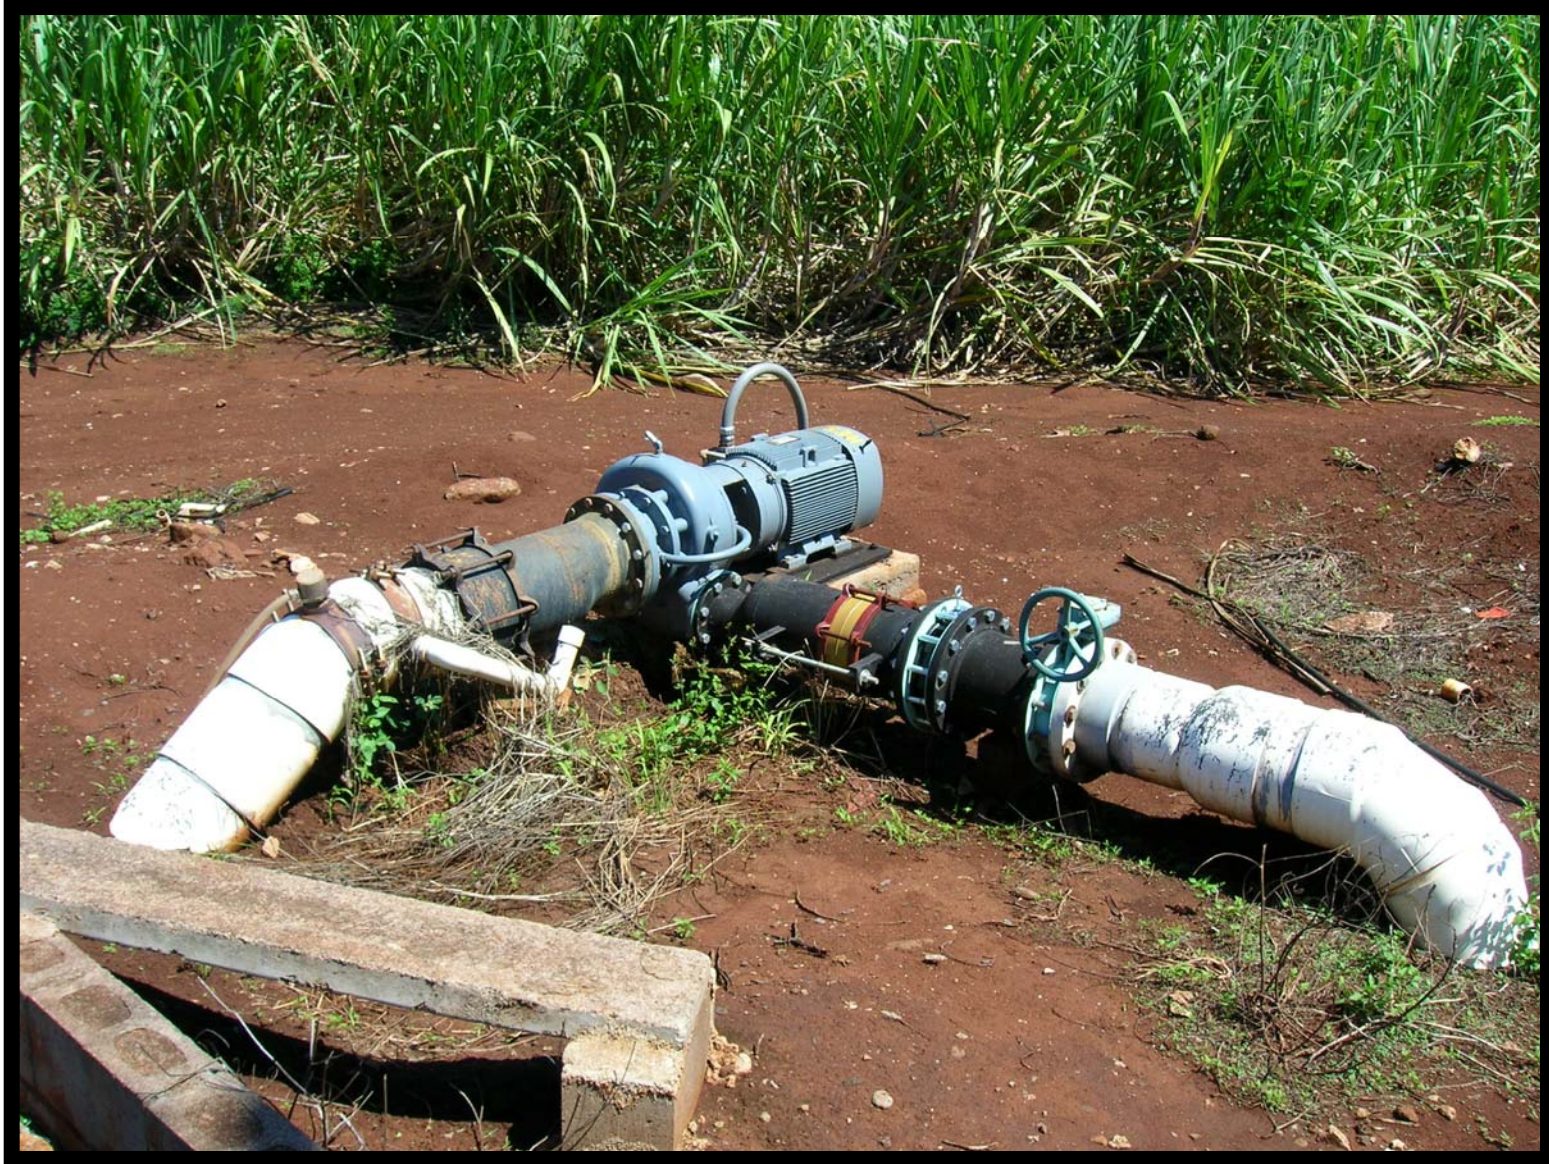
081 View of the pump that pumps the outlet water back up the irrigation ditch behind the reservoir.

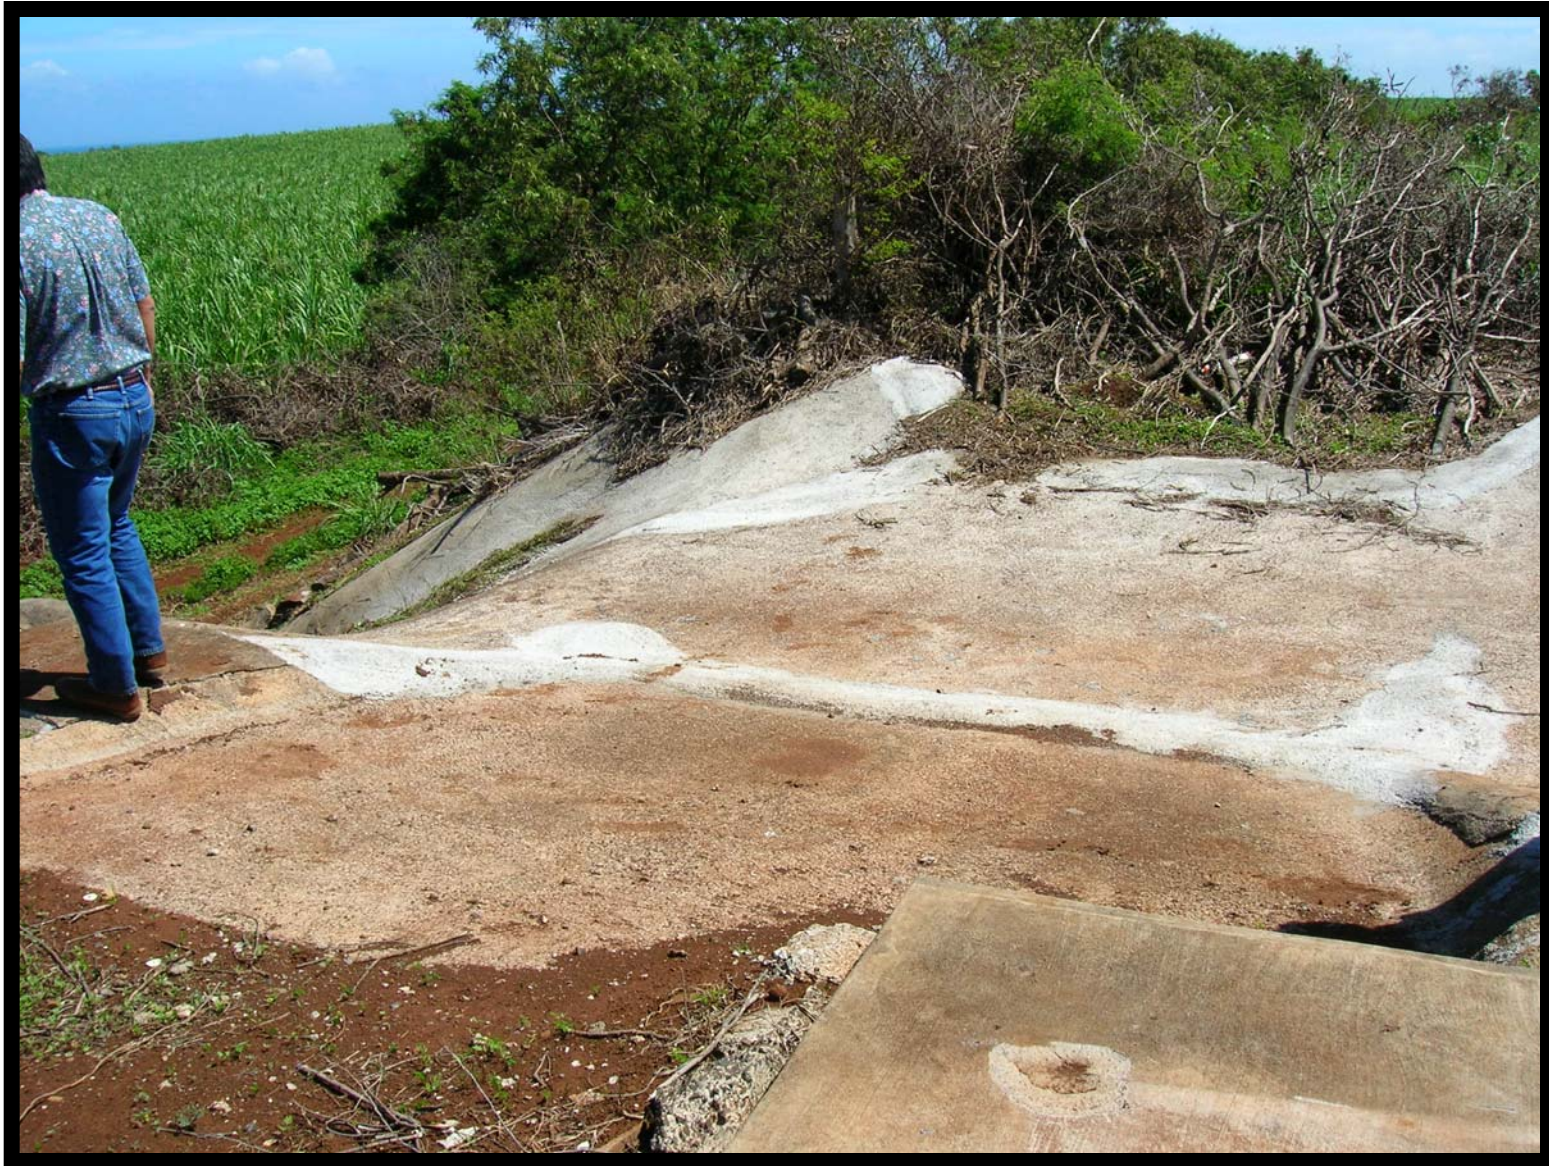
081 View of the spillway exit channel.
